NASA TM-78913

**FRACTOGRAPHIC EVALUATION OF CREEP EFFECTS ON STRAIN-
CONTROLLED FATIGUE-CRACKING OF AISI 304LC
AND 316 STAINLESS STEEL**

by Robert E. Oldrieve
Lewis Research Center
Cleveland, Ohio 44135
June 1978

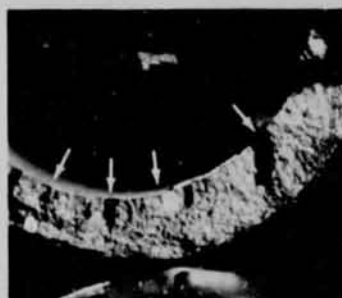
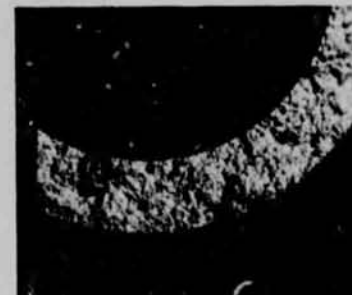
Figure 1. - Low strain ranges (0.4 to 0.9%), HTLCF produce characteristic fractures as shown (7050 Cl. Final fracture is at upper left-hand corners. AISI 316 stainless. X13.

(a) PP-cycle, $\Delta\epsilon_1 = 0.4\%$;
(11 980-), $\Delta\epsilon_{pp} = 0.4\%$.

(b) PC-cycle, $\Delta\epsilon_1 = 1.3\%$;
(1345-), $\Delta\epsilon_{pc} = 0.6\%$.

(c) CP-cycle, $\Delta\epsilon_1 = 0.5\%$;
(275-), $\Delta\epsilon_{cp} = 0.4\%$.

(d) CC-cycle, $\Delta\epsilon_1 = 0.4\%$;
(1150-), $\Delta\epsilon_{cc} = 0.3\%$.

A general finding of this investigation is that creep-fatigue interaction results in a distinctive fracture appearance for each of four types of SRP test cycles. Figures 1 to 4 show fracture surfaces of AISI 316 stainless steel fatigued to failure in strain-controlled tests for nominal inelastic strainranges of 0.4 and 4 percent. Figures 1 and 2 are macrophotographs. Figures 3 and 4 provide SEM photomicrographs superimposed upon plots of inelastic strainrange versus cycles to

For AISI 316, at two levels of strainrange, the generally planar, mixed-fracture, appearance is evident in figures 1(d) and 2(d). A crescent-shaped crack front is evident in figure 1(d). The fracture has a distinctive semi-planar granular topography which is particularly evident in figures 2(d) and 12(b). The intergranular character of CC-cyclic fracture appears to be introduced by reversed creep strain as the crack front advances. The CC-cycle crack-propagation plot (fig. 13) was based on an average of measurements taken along several radial intercepts because of distortion and differing slip-band width in adjacent grains. Since a lesser percent of total cyclic life (about 35% to 45% at 4% to 0.4% strainrange, table II) was expended for CC-cycled specimens to initiate a crack 125 μm deep than for the PP or PC cycles, it might be expected that the CC-cycle would have the shortest total cyclic life of these three SRP-cycles. This is true, however, only at lower strainranges. At 4.0 percent inelastic strainrange, the lives of CC, PC, and PP-cycled specimens are about the same. The damaging aspect of the CC-cycle as compared to the PC and PP-cycle is the tensile creep component which produces early crack initiation to a depth of 125 μm . At inelastic strainranges below about 1 percent, a further contribution to damage may be associated with crack propagation-to-failure. It appears that intergranular cracking occurred in addition to transgranular cracking, most probably, at the crack front as it advanced. Compared to CP-cyclic life at any inelastic strainrange, it should be noted (fig. 4) that tensile creep (as in the CP-cycle) is an order of magnitude more damaging than tensile creep which is offset by compressive creep (as in CC). For either the CC or CP cycles it is probably tensile creep which produces the damaging intergranular cracking.

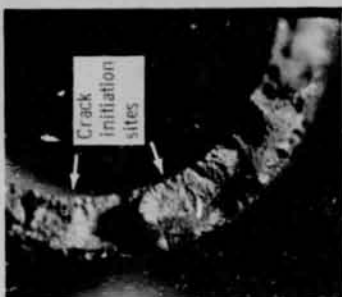
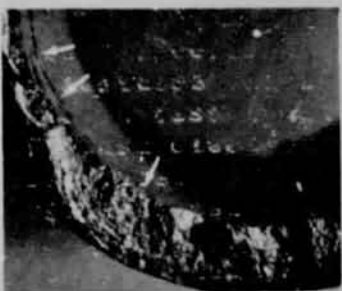
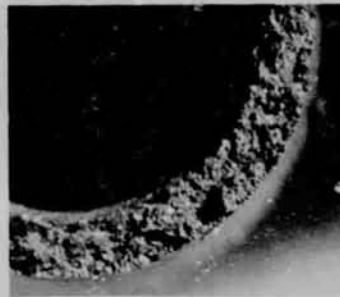
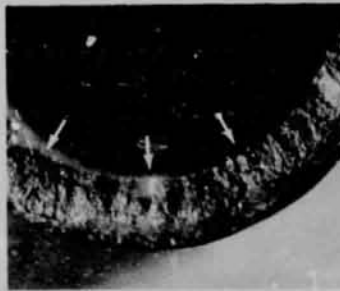
Figure 2. - High strain ranges (3.5 to 3.8%) HTLCF produce fractures with features accentuated but similar to characteristic low strain range HTLCF fracture, figure 1. AISI 316 stainless, 7050 C. X13.

(a) PP-cycle, $\Delta\epsilon_1 = 3.5\%$;
(102-), $\Delta\epsilon_{pp} = 3.5\%$.

(c) CP-cycle, $\Delta\epsilon_1 = 3.7\%$;
(12-), $\Delta\epsilon_{cp} = 2.5\%$.

(b) PC-cycle, $\Delta\epsilon_1 = 3.6\%$;
(88-), $\Delta\epsilon_{pc} = 2.5\%$.

(d) CC-cycle, $\Delta\epsilon_1 = 3.8\%$;
(98-), $\Delta\epsilon_{cc} = 3.3\%$.
